OPEN-FILE REPORT 79-485

PLATE 6 OF 12

COAL RESOURCE OCCURRENCE MAP OF THE SOUTHWEST QUARTER  
OF THE SCOFIELD 15-MINUTE QUADRANGLE,  
EMERY, CARBON, AND SANPETE COUNTIES, UTAH

PLATE 6  
OVERBURDEN ISOPACH MAP  
OF THE  
CANDLAND COAL BED

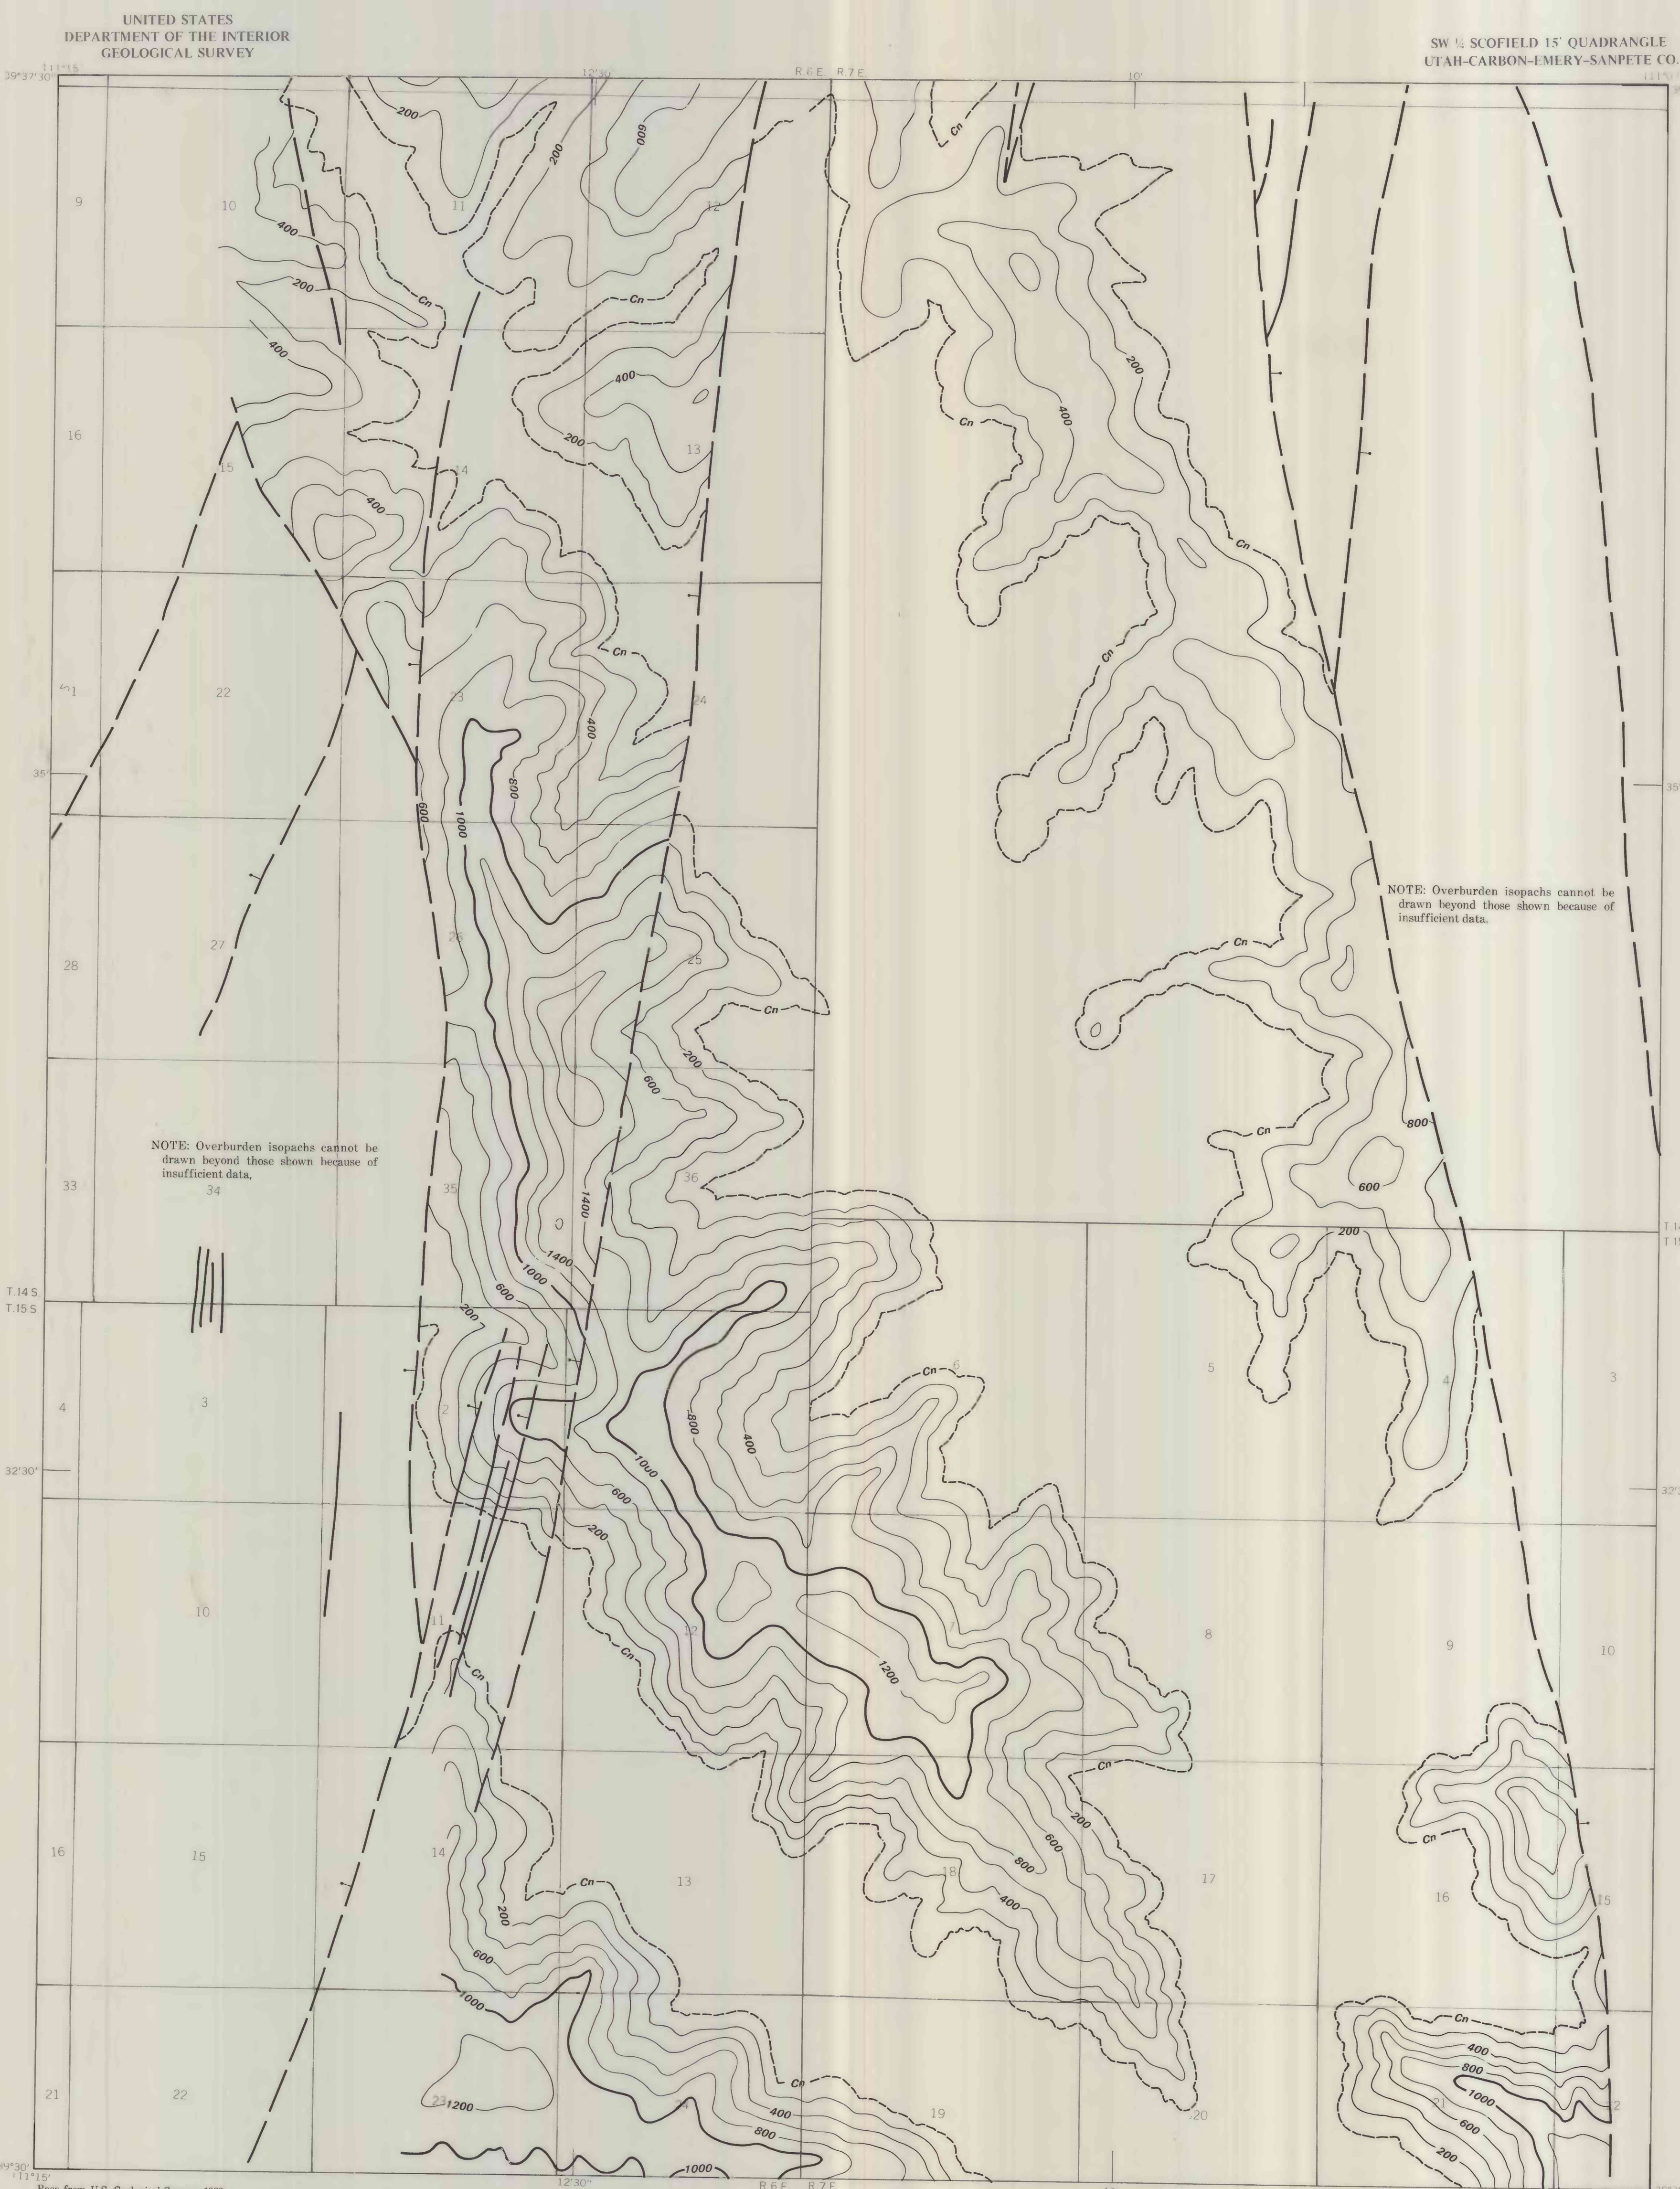
OVERBURDEN ISOPACHS - Showing thickness of overburden, in feet, from the surface to top of the Candland coal bed. Isopach interval 200 feet (61.0 m).

TRACE OF COAL BED OUTCROP - Showing symbol of name of coal bed. Dashed where inferred by present authors.

FAULT - Dashed where approximately located; bar and ball on downthrown side where direction of movement is known.
